Hydrogen Peroxide Paint Stripping

The helium tank farm and ancillary equipment, which supports Brookhaven National Laboratory's (BNL's) RIHC facility, needed to be stripped down to bare metal and repainted. Standard options would have included either grit blasting the paint off or using hazardous methylene chloride based strippers. The manpower costs, safety concerns and hazardous materials disposal costs, made these standard methods economically unfeasible for the 47 helium tanks and associated equipment.

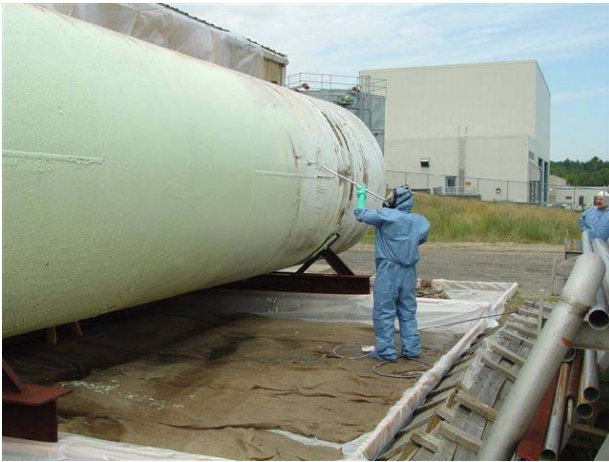
Photo #1 – Spray on application of the hydrogen peroxide stripper – notice the containment structure to capture the water from the power wash process and the burlap to capture the paint chips.

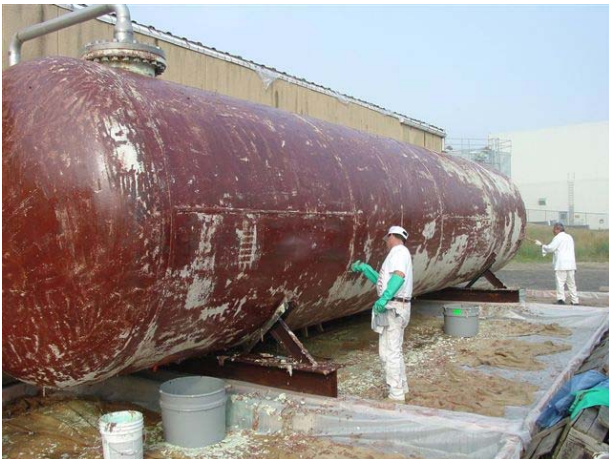
Photo #2 – paint chip removal process with a squeegee – notice the ease of removal and the minimal necessary PPE (work clothes, eye protection and gloves.)

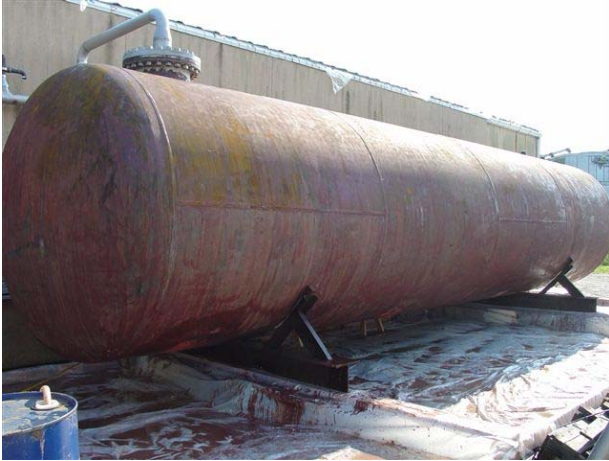
Photo #3 – Completely stripped tank – ready for priming and painting

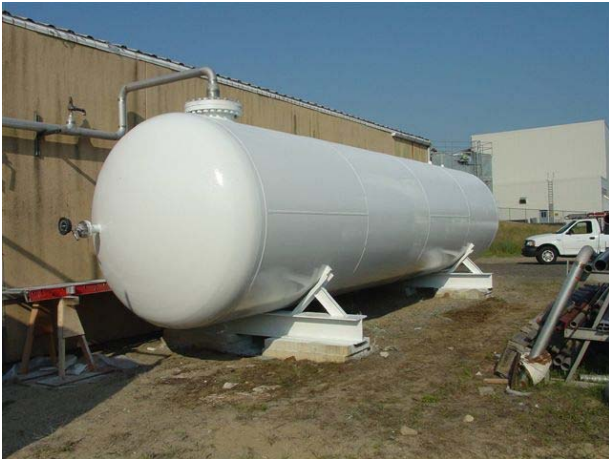
Photo #4 Completed tank

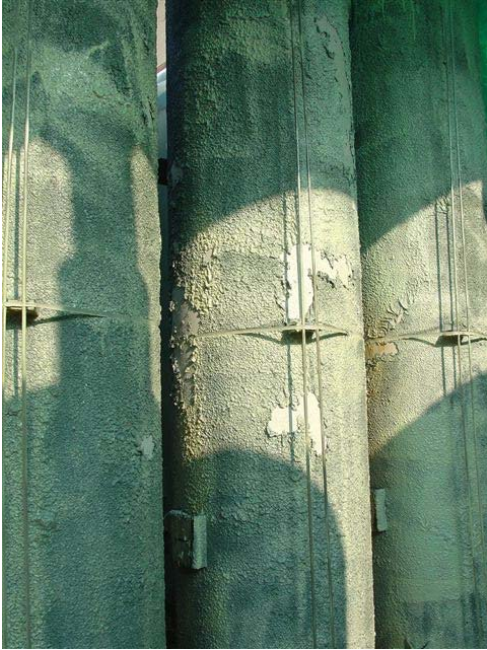
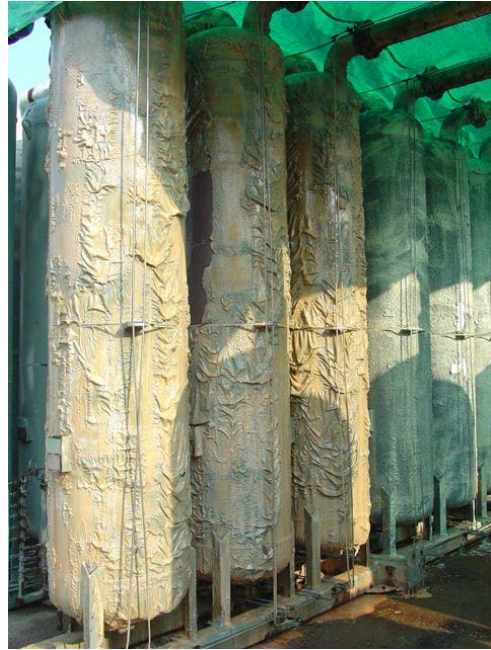
Photos #5 & #6 - Application of the hydrogen peroxide stripper to the oil mist eliminators and the efficacy of the product over time.

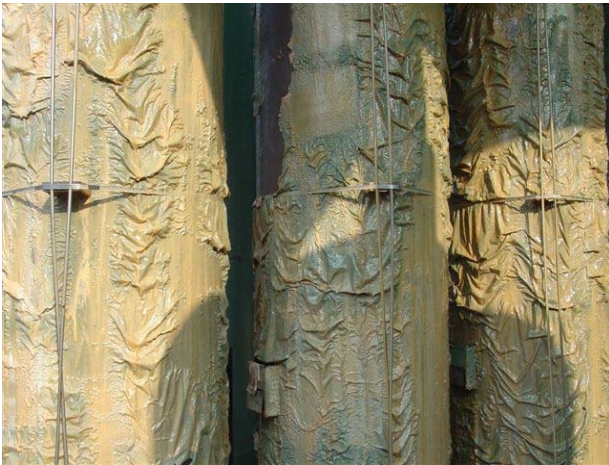
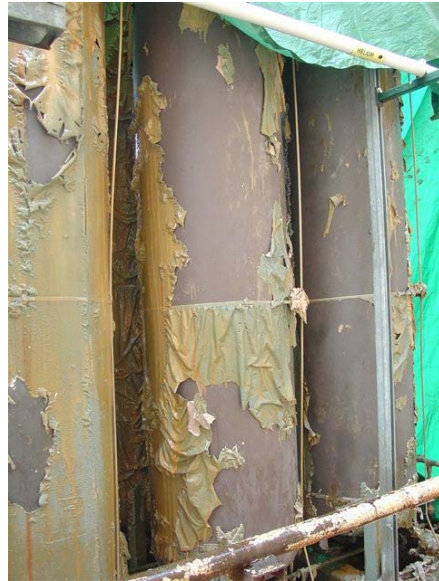
Photos #7 & #8 – Oil mist eliminators ready to be squeegeed

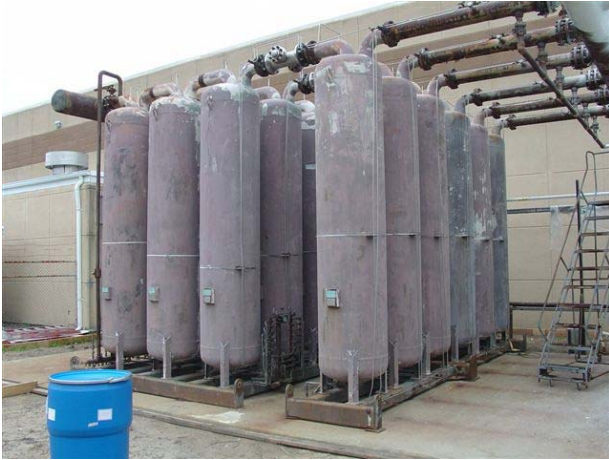
Photo #9 – Completely stripped oil mist eliminators – ready for priming and painting – note the limited spacing between columns and how difficult it would have been to use conventional methods to remove the paint.

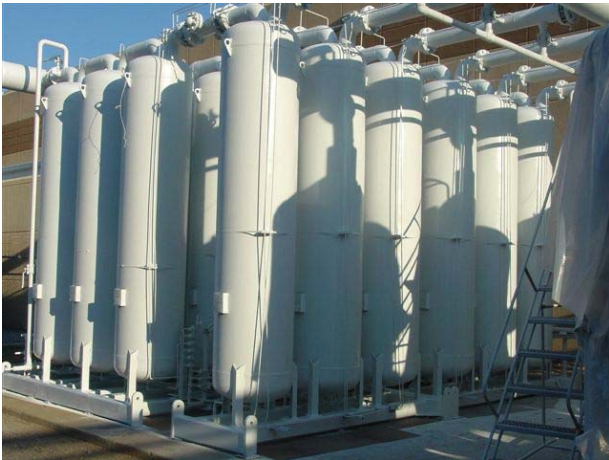
Photo #10 Completed oil mist eliminators.
